Porsche 968 Variocam Assembly: Inspection Procedure and Maintenance Schedule

Issue 1 April 2003.

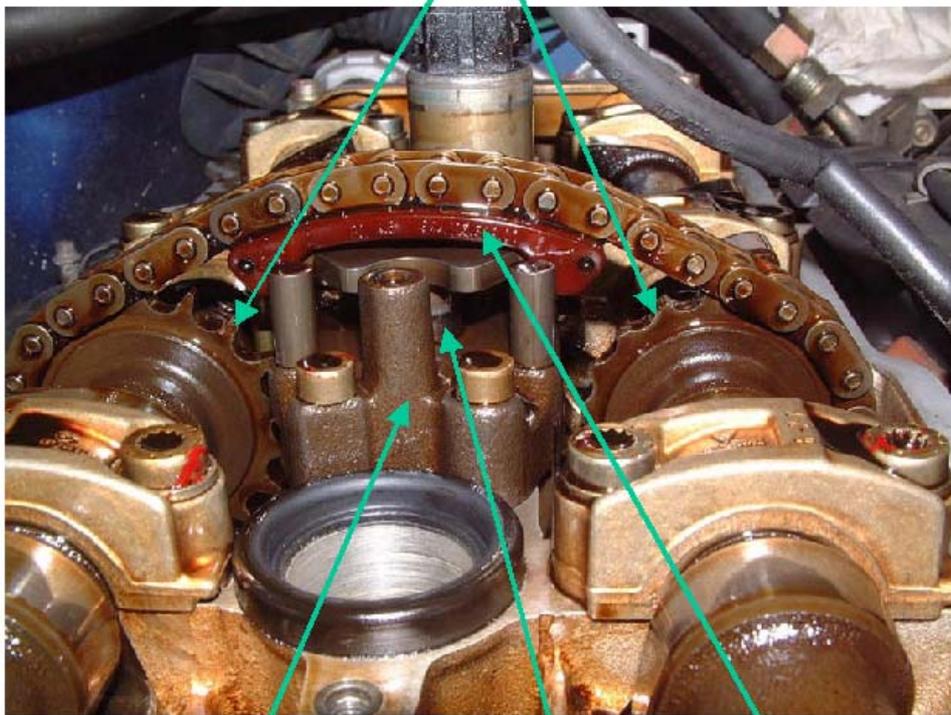
Figure 3

The effects of a stretched chain, are easily visible on **sprocket wear patterns**. Figure 5 shows a used but “serviceable” camshaft, while Fig. 3 shows a badly damaged

camshaft. Even if there are few or no missing teeth, a cam has to be changed when the central teeth part is too thin, hence prone to break. Compare teeth profile of fig. 3 (bad) with that of fig. 6 (new), and you have a good idea of how to judge your cam.

Camshaft sprockets
(note missing teeth on intake cam)

Damaged cams, 144,000 kms (89,000 miles)

21. Rotate the crankshaft sufficiently to turn the camshafts so that previously hidden teeth on the sprockets can be inspected. Continue until all teeth have been properly inspected (requires two complete crankshaft revolutions). Any missing or badly damaged teeth will require camshaft replacement (see figure 3).

If you change one camshaft, do not mix used and new ones: via the new chain, the wear pattern is rapidly transferred from the used cam to the new one, and in a few thousand miles, you will have two badly used cams. You have only two options:

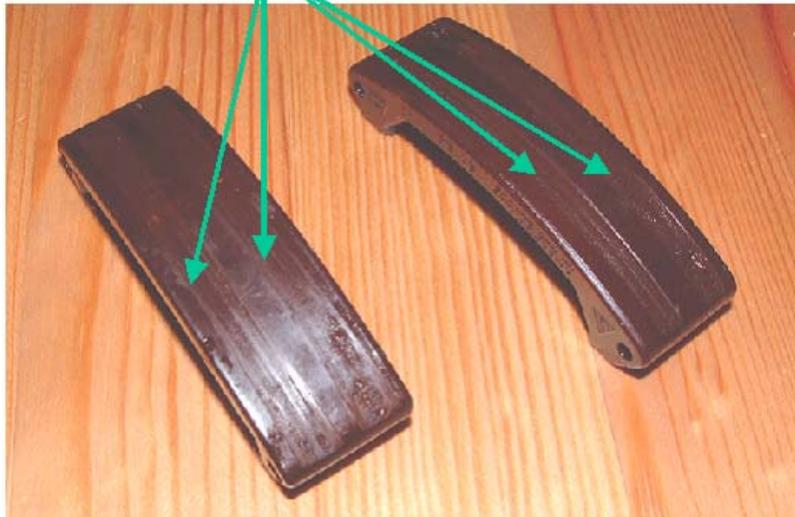
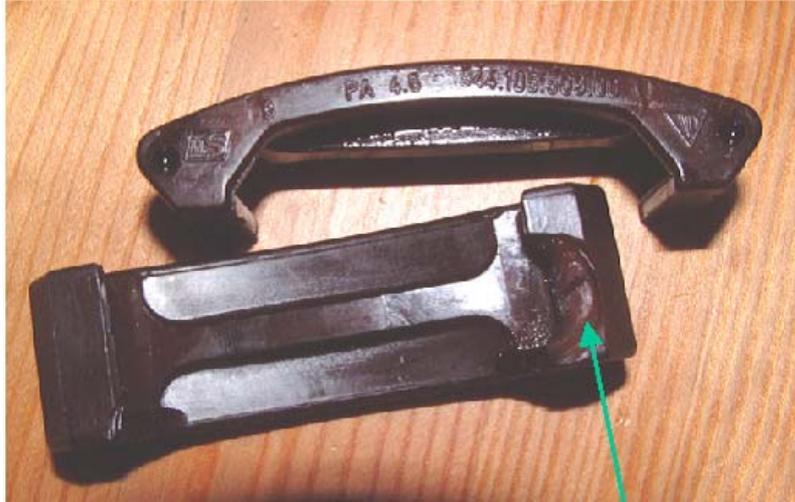
Figure 4

- Dark brown color of pads (new ones are light brown). This is not a definitive criterion, but comparing fig. 4, 5, 6 you can see that the darker pad is the worst one;
- Small “craters” visible in the wear grooves. These craters means the nylon is brittle, and small chunks of material are thrown away in stress conditions. In normal wear, the grooves have an “even” surface. If you have rough surfaces, clearly visible in Figure 4, immediately change both pads.

Wear Grooves

Broken Section

Old Tensioner Pads

To avoid major problems, change pads every 8 years, even if the “wear limits” are apparently not yet reached.

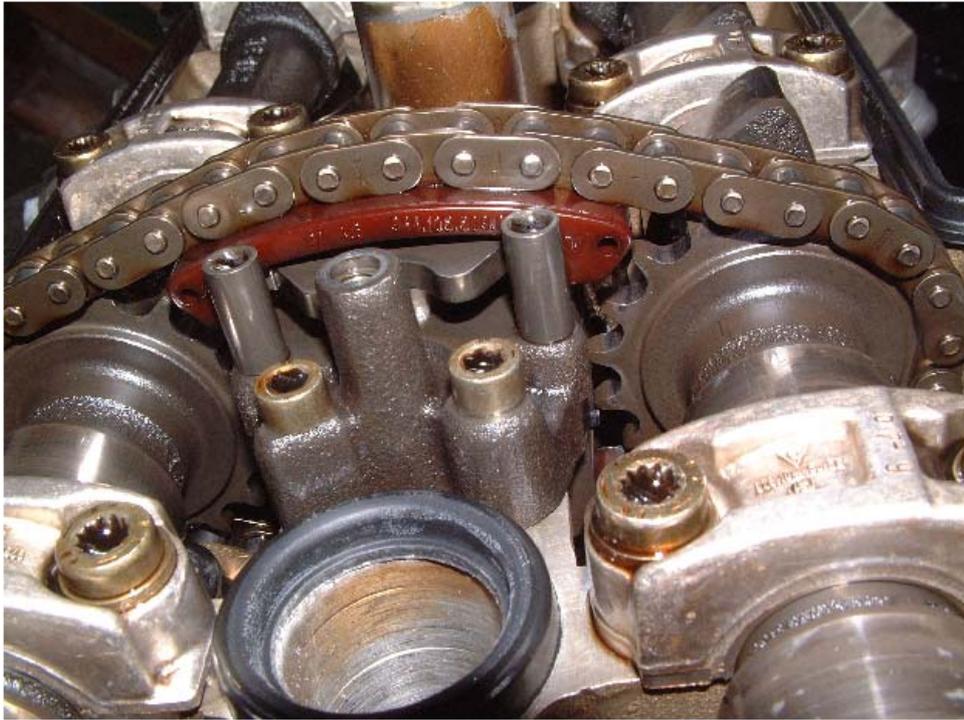
Figure 5

Serviceable Cams, 130,000 km car
