Porsche 968 Variocam Assembly: Inspection Procedure and Maintenance Schedule

Issue 1 April 2003.

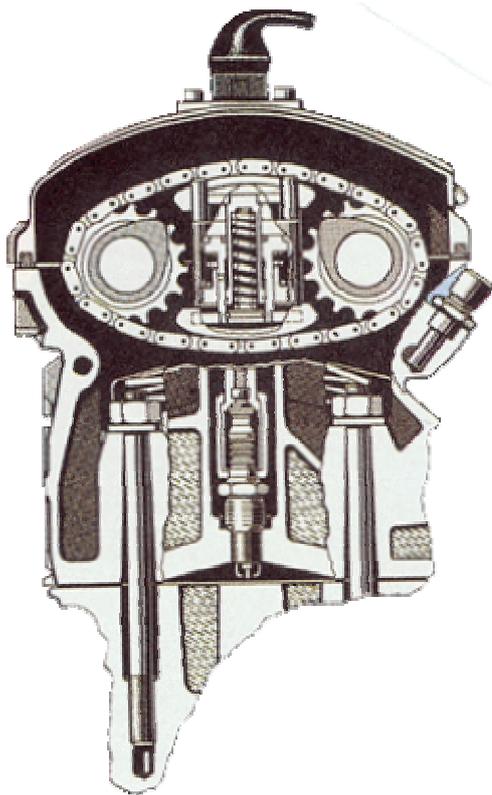
Cross Section Through Variocam Assembly

The diagram above shows a cross-section through the Variocam. The actuation mechanism comprises a housing that is bolted to the engine. The housing incorporates separate moving upper and lower tensioner pistons, each having a plastic rubbing pad that acts directly onto the upper and lower chain runs. The distance between the upper and lower tensioner pads is maintained by an internal spring, supplemented by constant engine oil pressure when the engine is running. This spring and oil pressure maintains correct chain tension, in a similar fashion to the earlier 944 series cars. The vertical position of the pistons is controlled by engine oil pressure. When the engine is running, engine oil pressure, controlled by a shuttle valve actuated by an electrical solenoid attached to the Variocam body, is directed to either lift or lower the pistons, depending on engine rpm. Below 1500 rpm, the DME unit (main control computer) energises the solenoid, moving the position of the hydraulic shuttle valve in the Variocam, thereby directing oil to lift the pistons. As the pistons lift, so the plastic pad on the rising top piston pushes upwards on the upper run of the chain,

causing it to extend. At the same time, the rising lower piston allows the lower chain run to be shortened. The overall effect is that the intake camshaft is rotated anticlockwise in relation to the exhaust camshaft, thereby retarding the intake timing back to its nominal setting. Above 1500 rpm, the DME de-energises the Variocam solenoid, causing the shuttle valve to move to a different position. Engine oil pressure is then redirected to lower the pistons, extending the lower chain run and shortening the upper chain run. This causes the intake camshaft to rotate clockwise in relation to the exhaust camshaft, advancing the intake timing by 15 degrees. Above 5500 rpm, the solenoid is again energized, and the intake cam is retarded back to its nominal position.

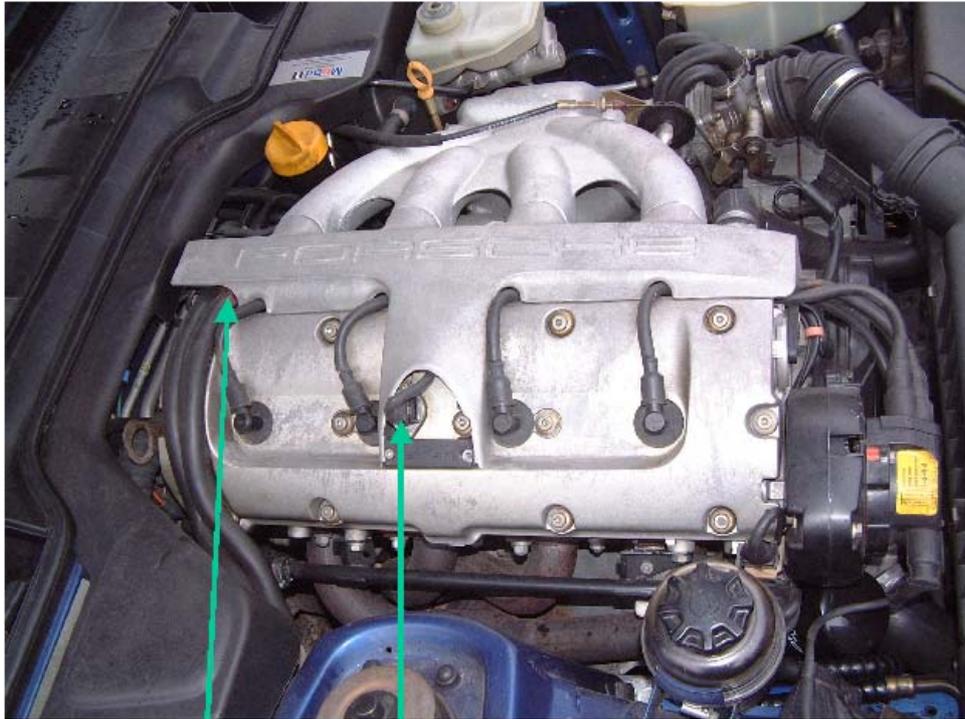
Figure 1

Fuel hose connectors

Variocam electrical connector

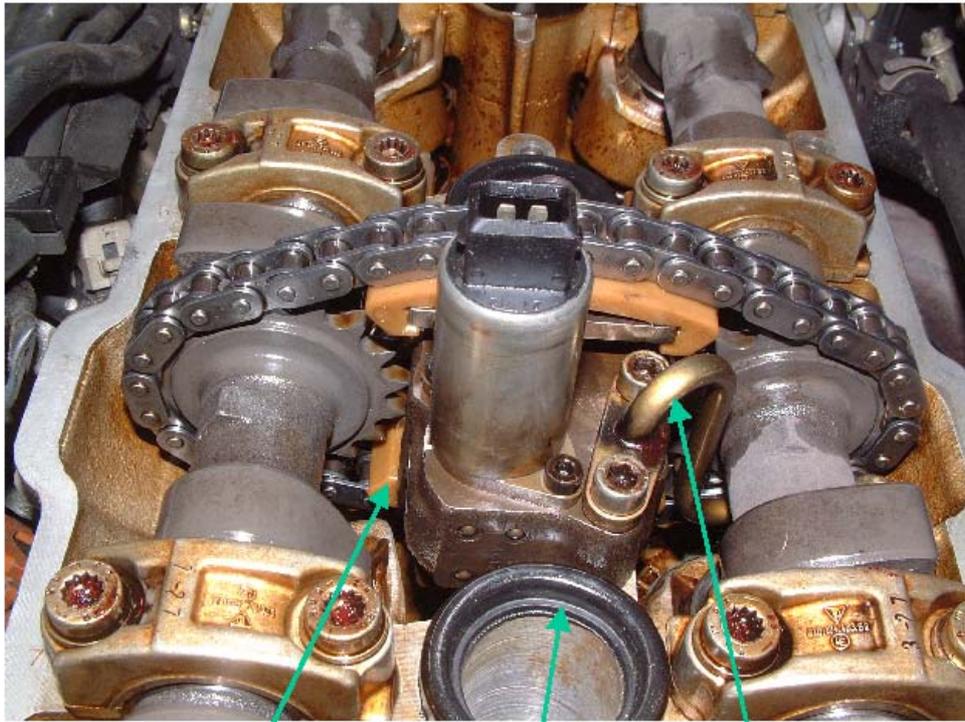
Lower Tensioner Pad

Oil Feed Pipe

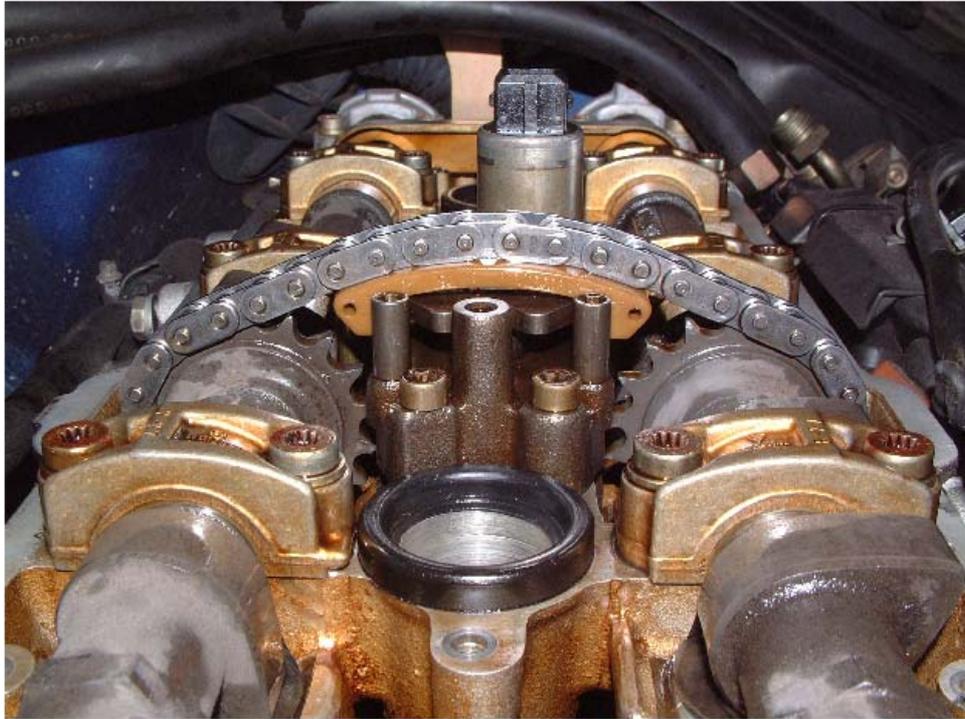
Figure 6

camshaft. Even if there are few or no missing teeth, a cam has to be changed when the central teeth part is too thin, hence prone to break. Compare teeth profile of fig. 3 (bad) with that of fig. 6 (new), and you have a good idea of how to judge your cam.

Brand New Cams, Chain, Tensioner Pads
